MR No. E6E31

NATIONAL ADVISORY COMMITTEE FOR AERONAUTICS

THE EFFECT OF LIQUID AND ICE PARTICLES ON THE  
EROSION OF A SUPERCHARGER-INLET COVER  
AND DIFFUSER VANES

By Vern G. Rollin

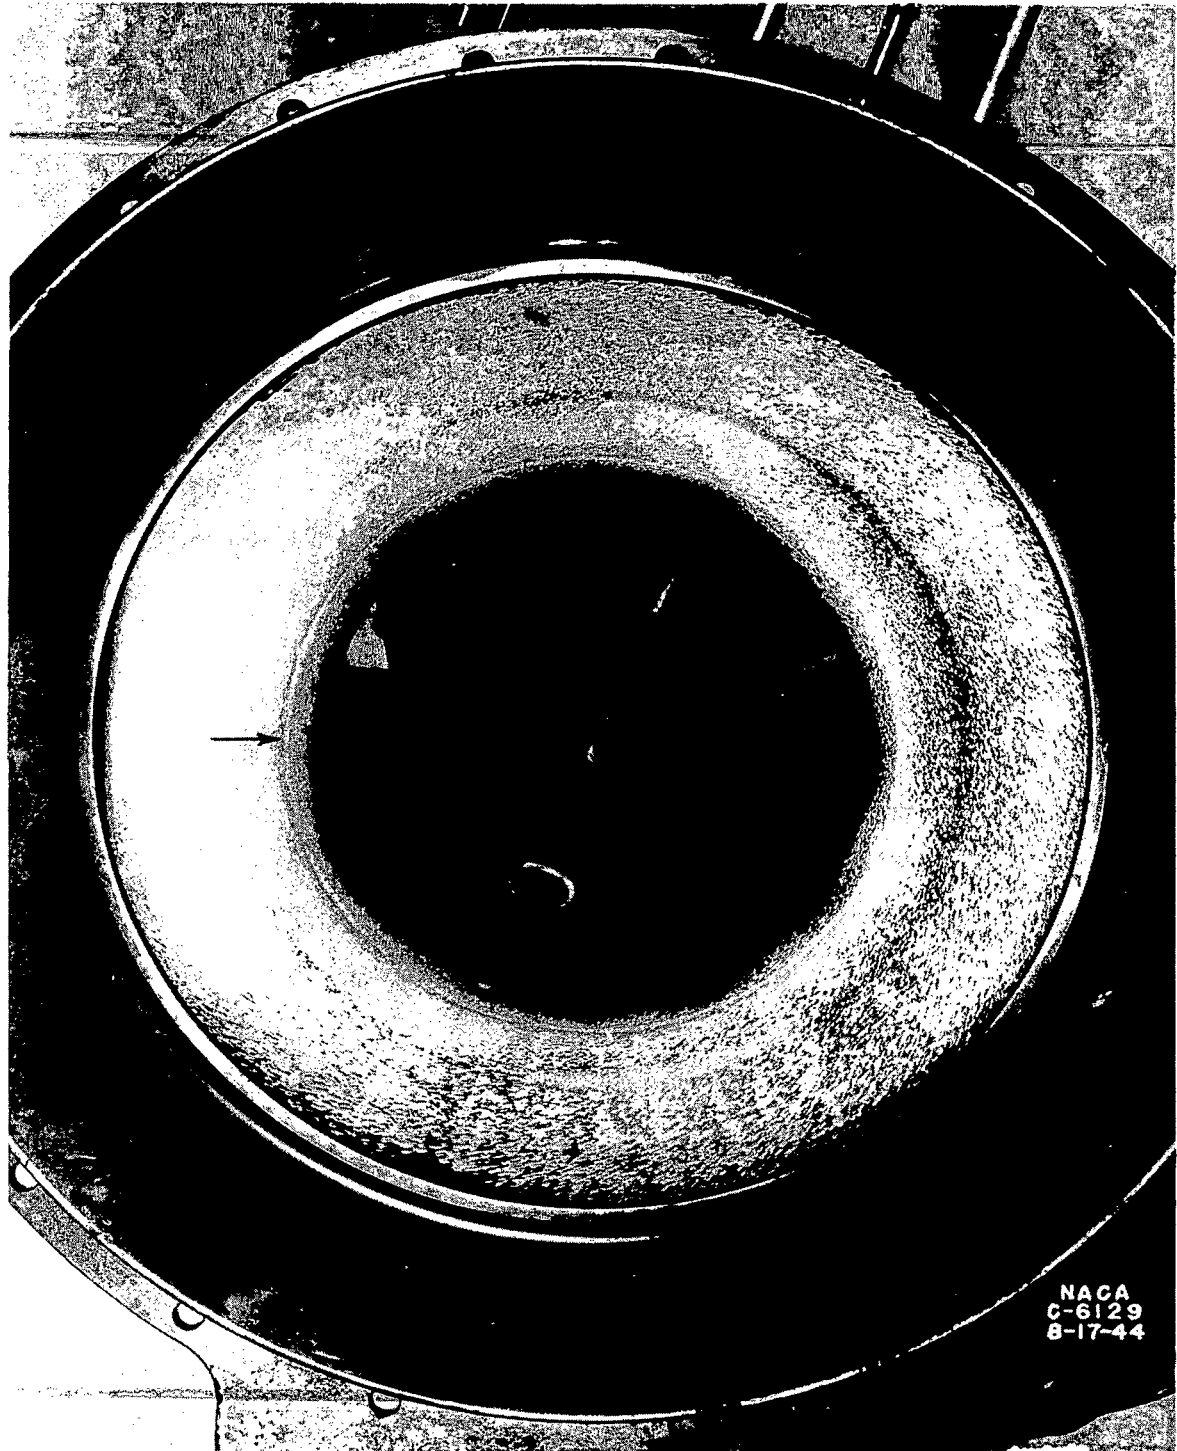
During an overhaul of the setup used for the icing investigations described in references 1 and 3, the inner surface of the supercharger-inlet cover in close proximity to the impeller was observed to be badly eroded. Erosion reached a depth of approximately 0.030 inch and was much worse on the left side than on the right side of the inlet cover, as seen in figure 1(a). The deeper annular depression noted by the arrow was located just opposite the point where the steel inducer joins the aluminum impeller. The

erosion was more uniform on the portion of the cover shown at the left of the photograph; ice that formed in the bottom of the elbow would first strike this area when loosened during the de-icing process because the supercharger impeller rotated in a clockwise direction as viewed from the front of the engine. The leading edges of two of the six diffuser vanes are shown in figure 1(b). Erosion removed about three-eighths inch of metal from the leading-edge portion of the diffuser vane near the curved surface of the cover.

Consideration of the seriousness of this problem prompted a survey of the running time and test conditions for the setup. It was found that the total running time for this setup prior to inspection had been 861 hours, which included 110 hours operation with rain ingestion simulated by spraying water into the air stream about  $6\frac{1}{2}$  feet above the carburetor top deck at an average rate of 46.3 pounds per hour. During the determination of icing characteristics,  $8\frac{1}{4}$  hours of the running time had been at simulated operation with water injection in the inlet elbow by means of a special nozzle large enough to accommodate the combined volume of fuel and water. These runs were made at air flows simulating take-off power with an average rate of water injection corresponding to a water-fuel ratio of 0.4. The amount of the observed erosion caused by passage of ice through the supercharger could not be determined.

(a) Surface erosion at entrance to impeller.

Figure 1. - Effect of liquid and ice particles on erosion of supercharger-inlet cover resulting from 110 hours of operation under various icing conditions.

Erosion of the diffuser-vane leading edges may be prevented by use of an erosion-resistant metal. Elimination of the discontinuity where the steel inducer joins the rest of the supercharger would prevent grooving the cover at that point. A more durable corrosion-resistant surface would reduce inlet-cover erosion. Erosion caused by ice could be materially reduced by excluding water drops from the system before they reach the carburetor and by changing the method of fuel injection to prevent fuel-evaporation icing (reference 4). Erosion caused by water or water-alcohol injected with the fuel could be eliminated by injecting the water downstream of the supercharger. This factor may become increasingly important with extended use of water injection for increased power ratings of aircraft engines.

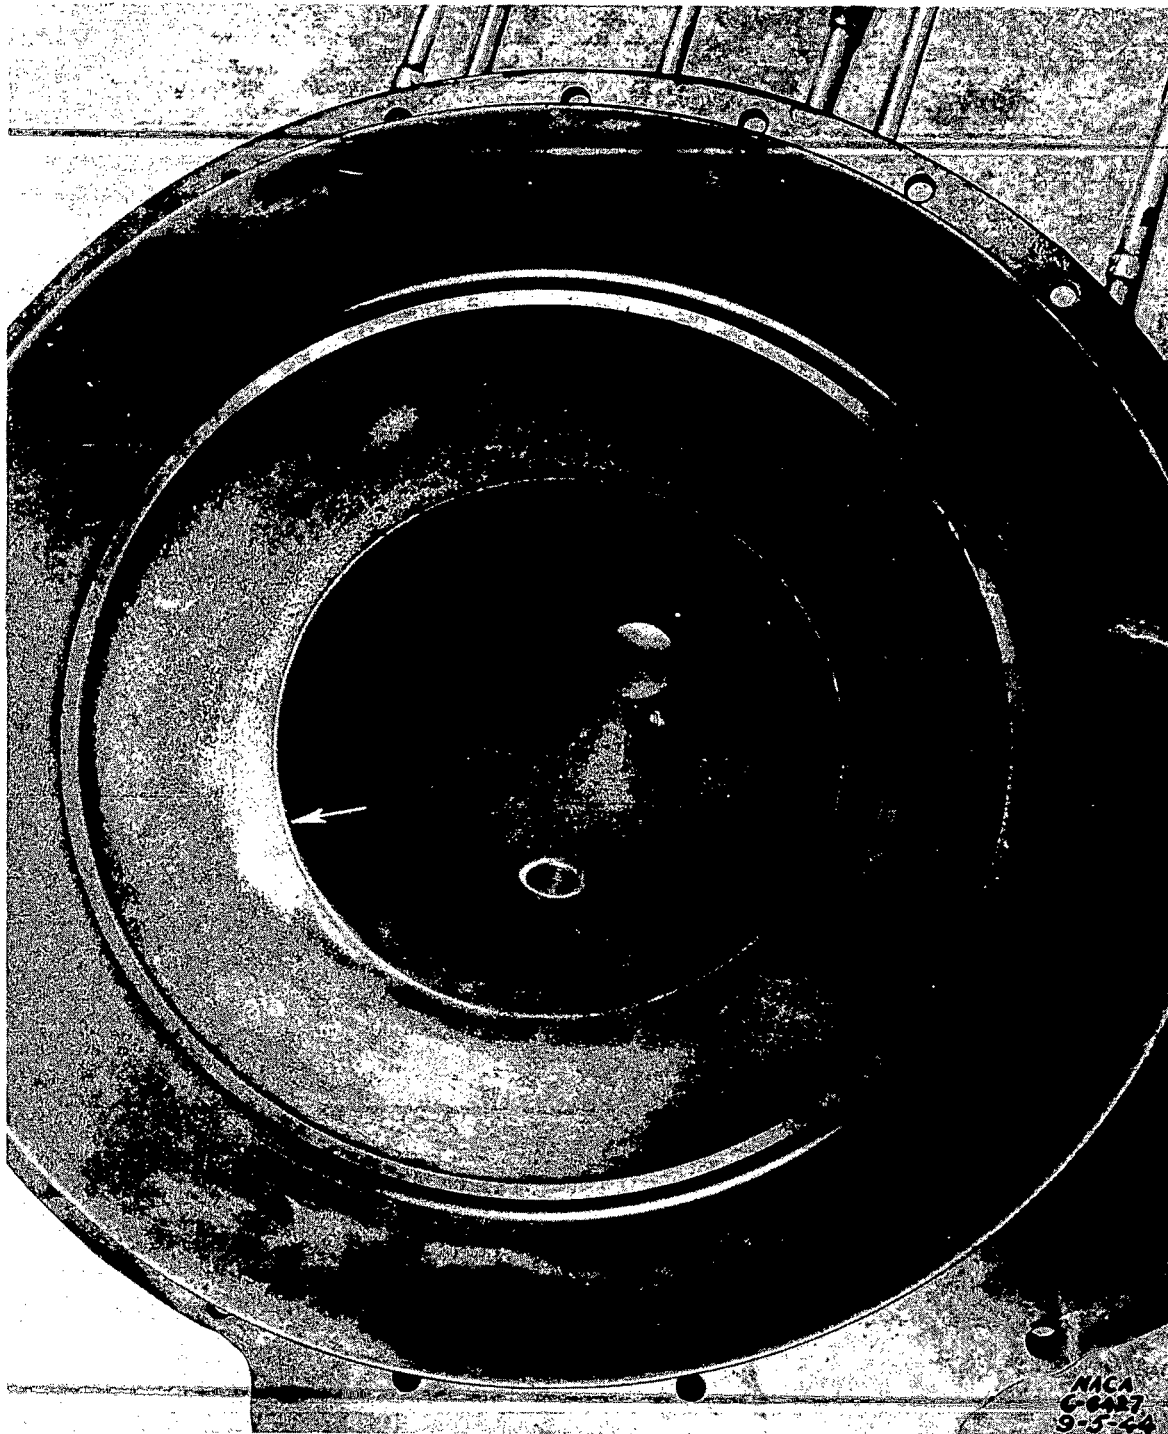
In the attempt to isolate the causes of erosion, the next two tests were made at take-off power conditions for  $8\frac{1}{4}$  hours during which the liquid and air temperatures were maintained at about  $75^{\circ}\text{F}$  to prevent ice formation in the system. The erosion effect of liquid injected at a rate corresponding to a fuel-air ratio of 0.08 and a water-fuel ratio of 0.6 is shown in figure 2. The erosion effect of water alone on another inlet cover injected at a rate of approximately 485 pounds per hour for  $8\frac{1}{4}$  hours is shown in figure 3.

(a) Surface erosion at impeller entrance.

Figure 2. - Erosion of supercharger-inlet cover caused by water and fuel injection. Rate of liquid injection, 1300 pounds per hour; duration of test,  $8\frac{1}{4}$  hours.

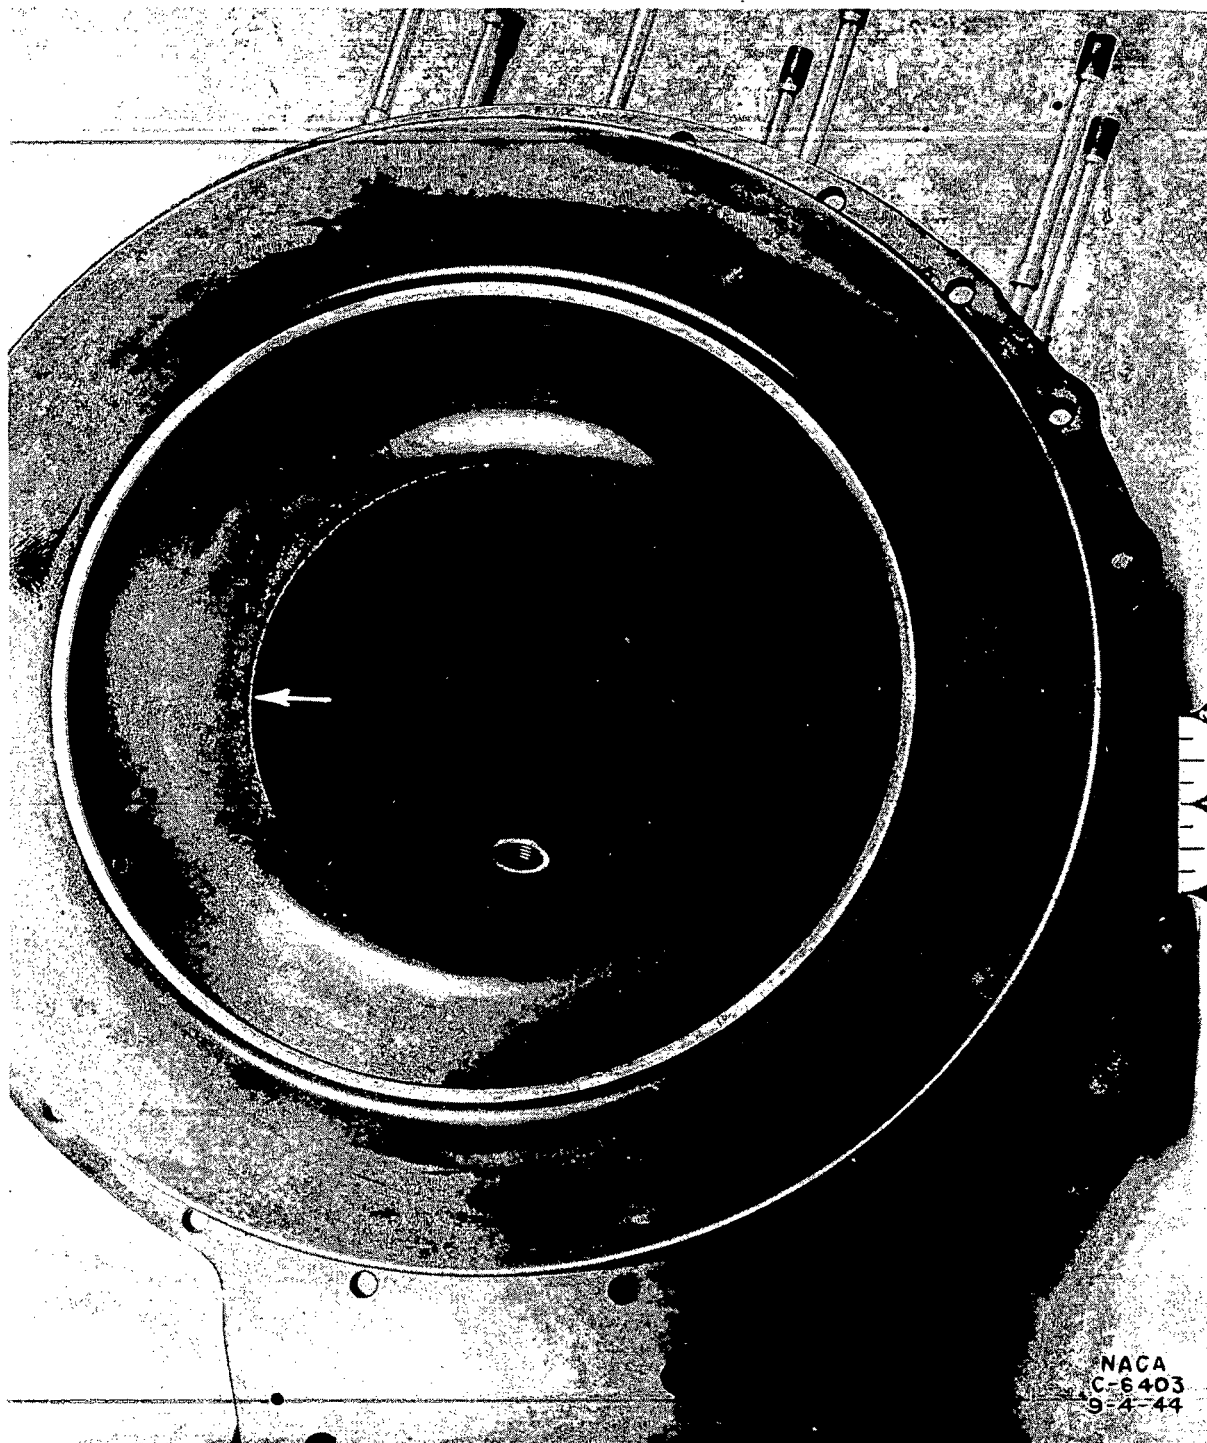
(a) Surface erosion at impeller entrance.

Figure 3. - Erosion of supercharger-inlet cover caused by water injection. Rate of water injection, 485 pounds per hour; duration of test,  $8\frac{1}{4}$  hours.

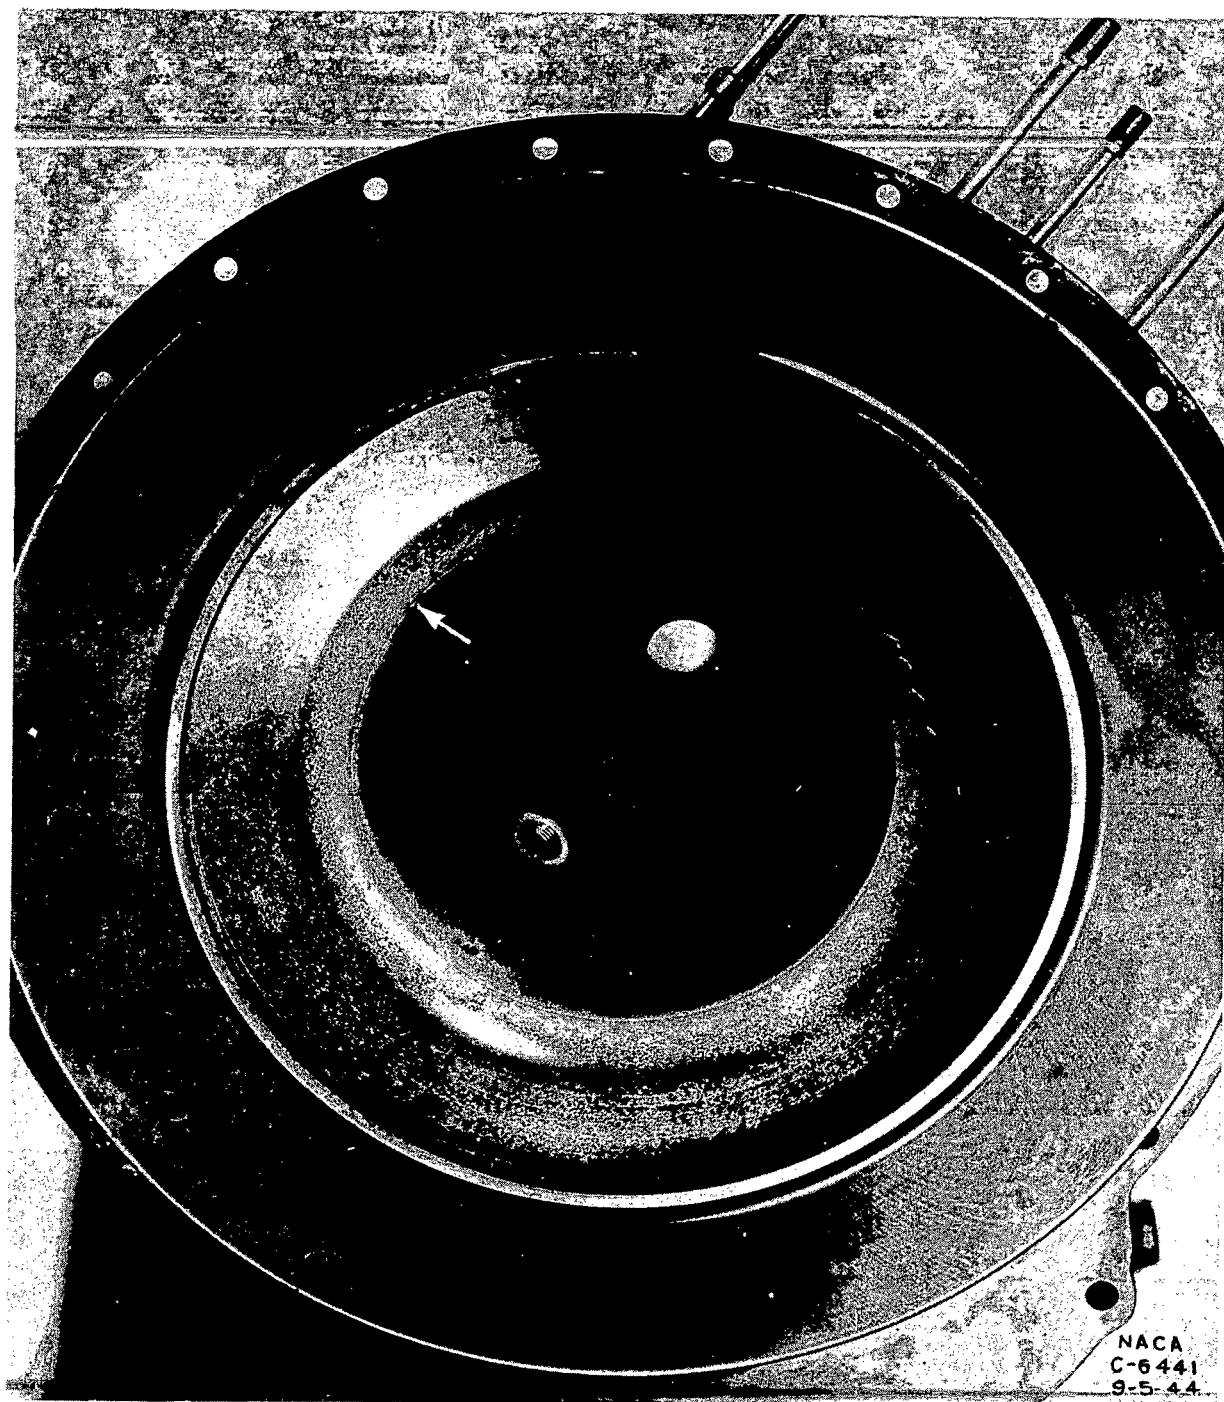
The results of the third accelerated erosion test of  $8\frac{1}{4}$ -hour duration (fig. 4) indicate that the passage of ice through the supercharger caused most of the damage. In this case the inlet cover had been reconditioned after the mild erosion shown in figure 3. Ice, alternately formed and shed upstream of the supercharger at low carburetor-air temperatures, is apparently responsible for most of the erosion shown in figure 1.

(a) Surface erosion at entrance to impeller.

Figure 4. - Erosion of supercharger-inlet cover caused by water and fuel injection and ice particles. Rate of liquid injection, 1300 pounds per hour; duration of test,  $8\frac{1}{4}$  hours.
